# Queensland conditions no match for MISU

When a screening solution was required on the North Queensland Gas Pipeline Project, local excavation contractor R&J Lord Excavations turned to Wodonga based MISU.

## North Queensland Gas Pipeline

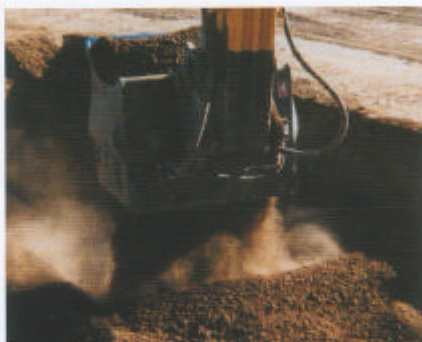
*Screening rather than crushing protects against potential coating damage.*

Speaking about the use of the MISU screening unit on the project, Richard said that it was important to note that the MISU bucket was a screening bucket rather than a crushing bucket as a crushing system could put hard splinters on the gas pipeline leading to potential coating damage.

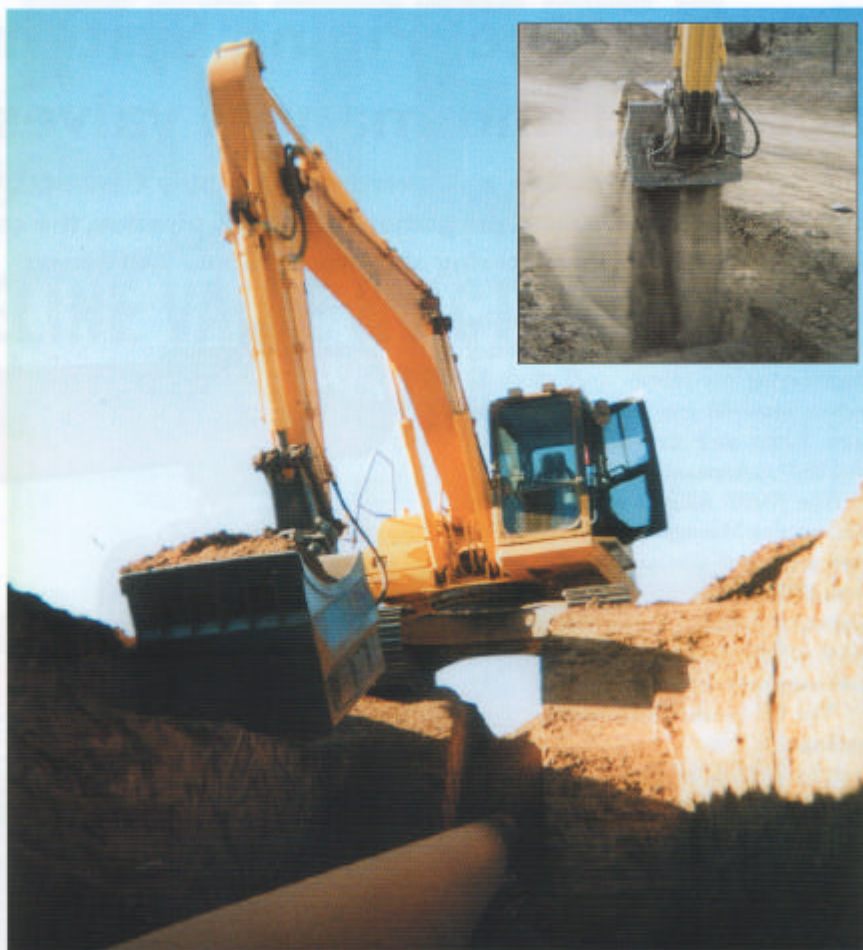
*A MISU screening unit in action on R&J Lord Excavations' machine on the NQGP project. (Photos courtesy of Richard Lord)*

These harsh conditions, with many variable materials being screened, required heavy duty cleaning combs which were attached at the bottom of the unit (fines exit point), with the fingers of the combs between each rotor blade. The unit's material engaging parts are constructed from Hardox 500, ensuring their longevity.
